**Freedom of Information request: Japanese Knotweed at the New Velindre Cancer Centre (nVCC) (CORP 2024 – 138)**

**INVASIVE SPECIES REPORT & MANAGEMENT  
PLAN**

'Old Access Route' - Japanese Knotweed Disposal Records and Associated Information

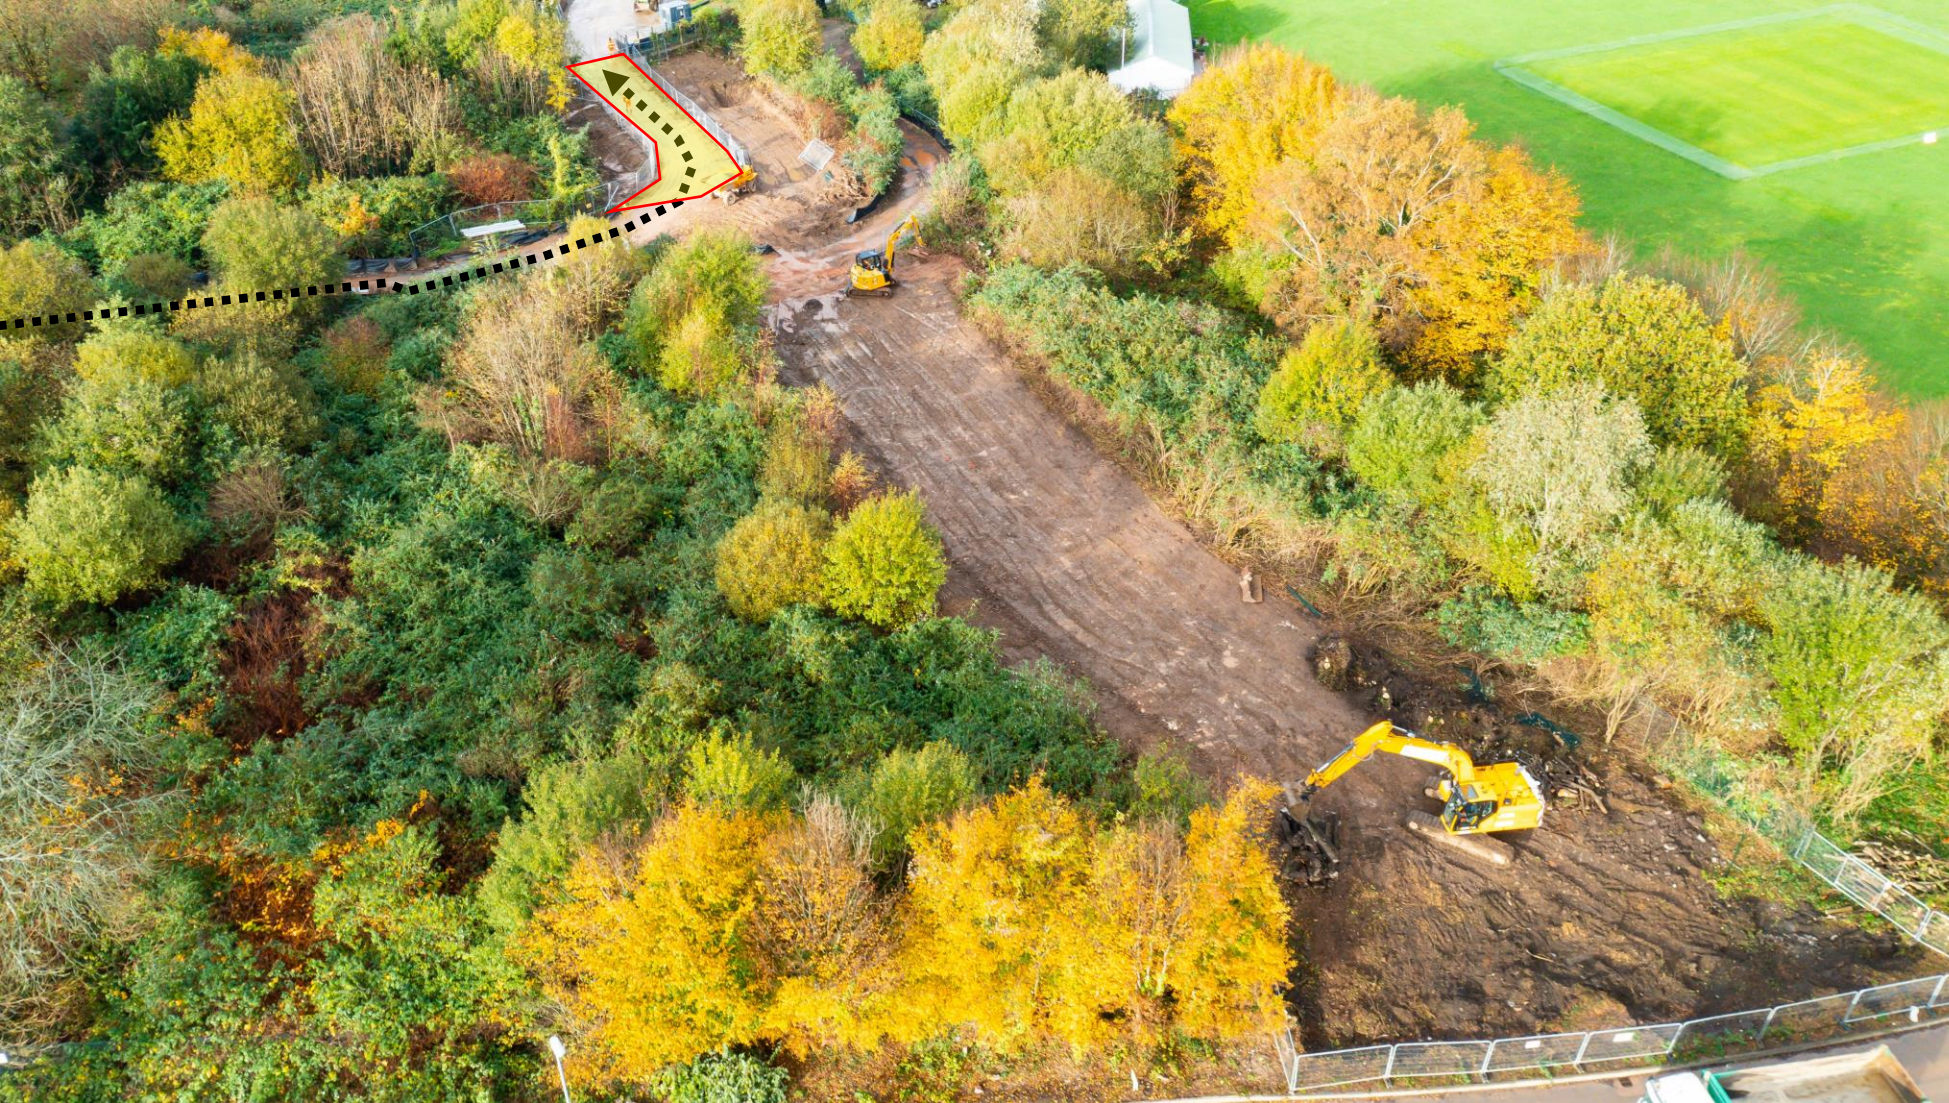
1. The image shown is from the site clearance and excavation stage of TCAR2 but it serves to provide the overall appreciation of works carried out at this location, so is repeated throughout.

2. When permission to commence the Enabling Works contract proper was received, the route indicated with a black dotted line was utilised, but before this could be trafficked, Japanese Knotweed was cleared from the yellow highlighted zone, inside the red border indicated - this was undertaken on **17<sup>th</sup> and 18<sup>th</sup> August 2022** (records have been provided previously for this work scope).

3. The JK barrier specification is included within this overall submission. The product name is Hy-Tex Root Barrier C3 (CE)
4. The following slide shows this area, where the JK was present at TCAR1 being excavated and the completed, filled area with the JK membrane visible at the edges following the filling operations at the perimeter.

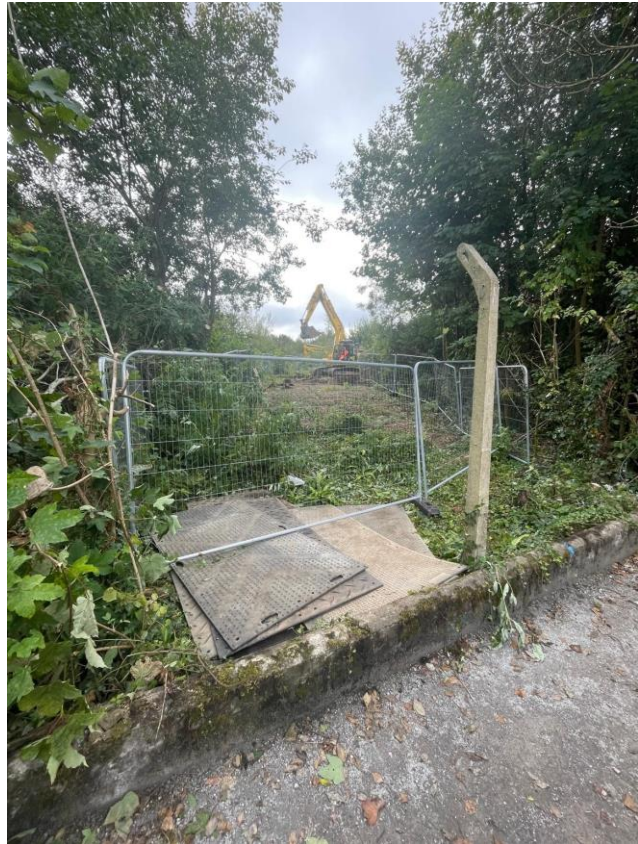
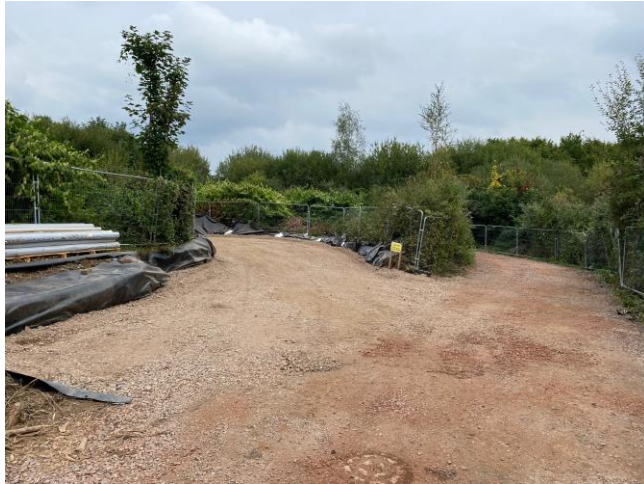
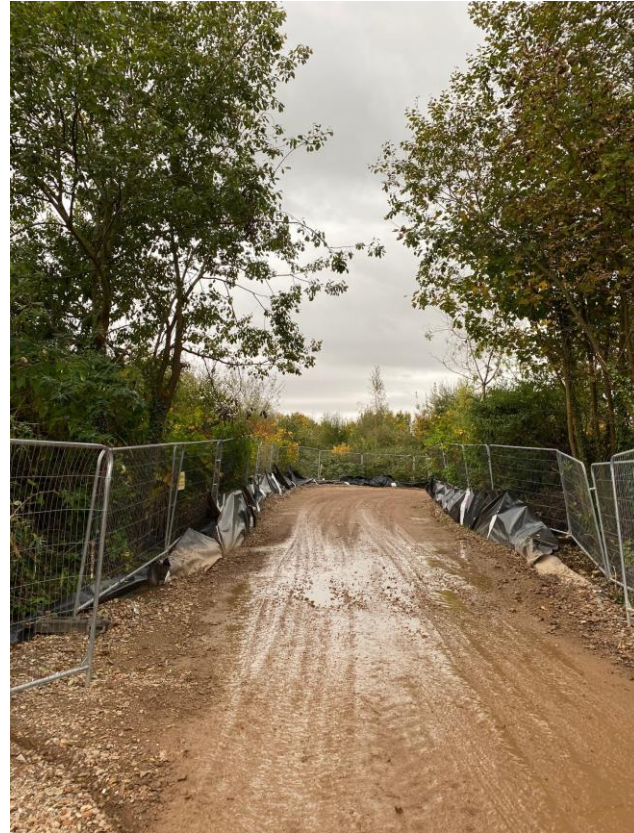
1. Image 1 shows the TCAR1 entrance to the nVCC development site (at the adopted path crossing zone) being excavated to remove the JK on **17/08/22**, image looking east towards the excavator.
2. Image 2 shows the completed filling with the JK barrier visible which followed, image looking north.
3. Image 3 shows the completed filling with the JK barrier visible, image looking east again.
4. The JK removal operation is as recorded on Batch 1 of the Neals Soils records, i.e. on **17<sup>th</sup> and 18<sup>th</sup> August 2022**.
5. Batch 1 of Neal Soils records are as provided previously, refer to email of **01/07/24** (MRY to RD).
6. These excavation works were carried out in the presence of Walters INNS Management Consultant CSM Ecology.
7. The INNS Report and Management Plan of **April 2022** has been provided previously.

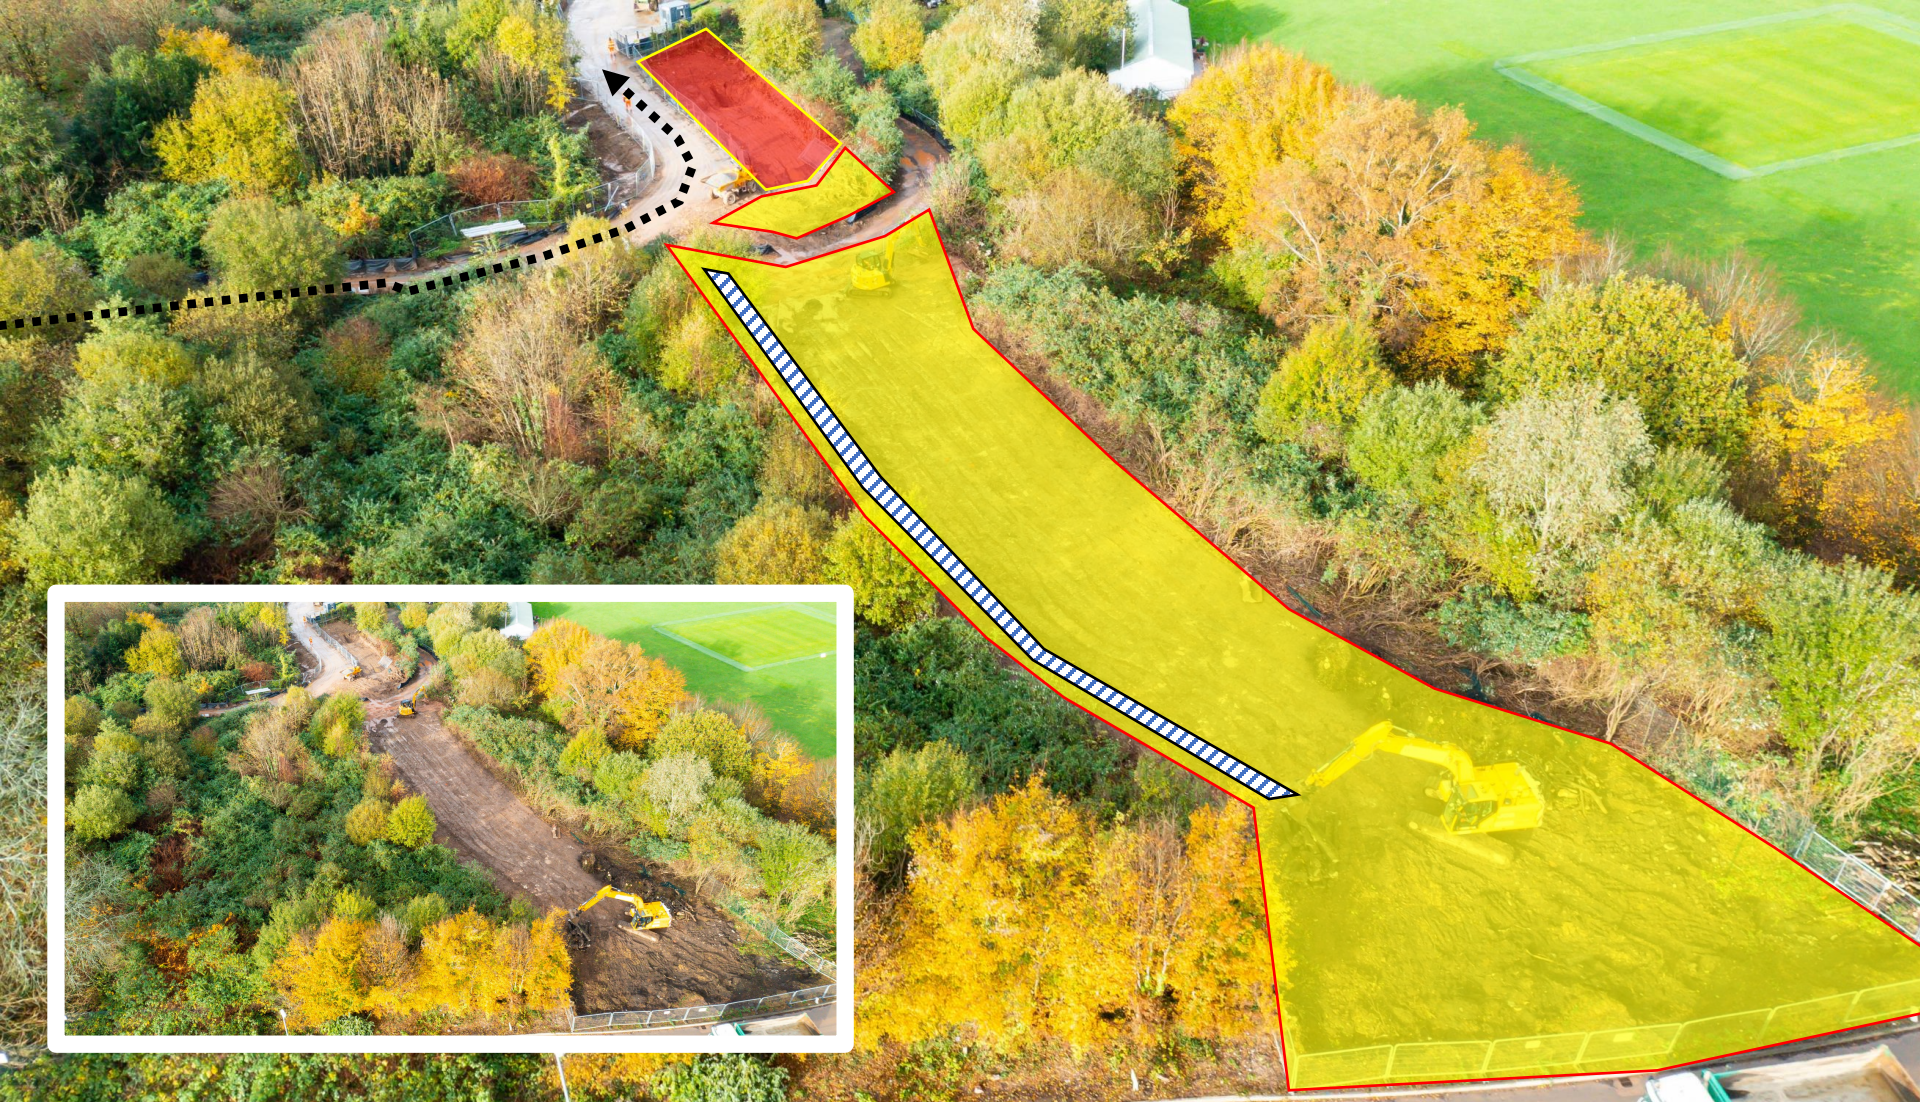
1. The route indicated in black dotted line was used in the ongoing period by Walters for their main access to the nVCC development field for the Enabling Works Projects from **August 2022 until TCAR2 was available in May 2023.**

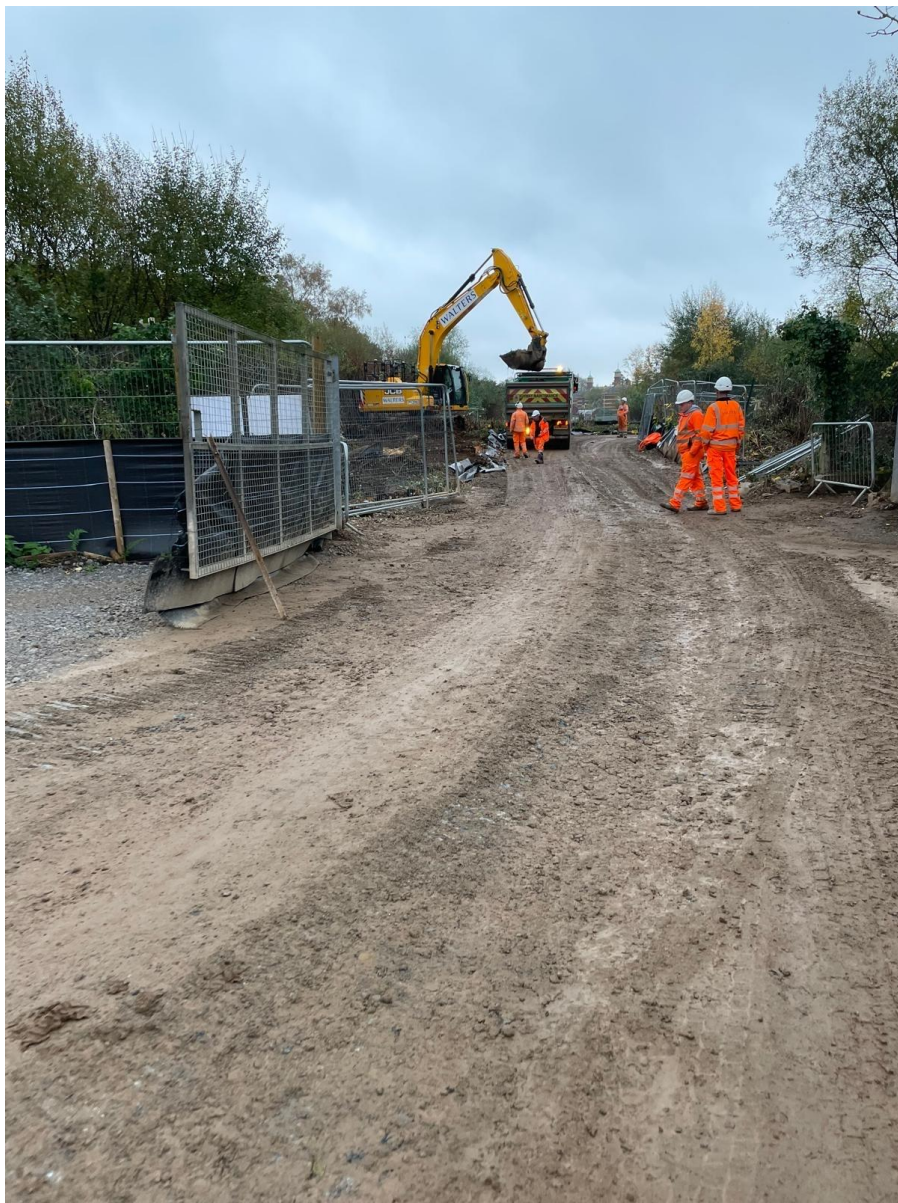
1. Image provided opposite shows the excavation of the INNS at the widened access road into the nVCC Development field, which is the creation of the additional width required to form the TCAR2.
2. The arisings are being loaded to the Neals Sils wagon and these loads going off site are recorded in the Batch 3 tickets dated 14<sup>th</sup> and 15<sup>th</sup> of November 2022.
3. The Walters RAMS detail how the cleanliness of the machinery was managed.

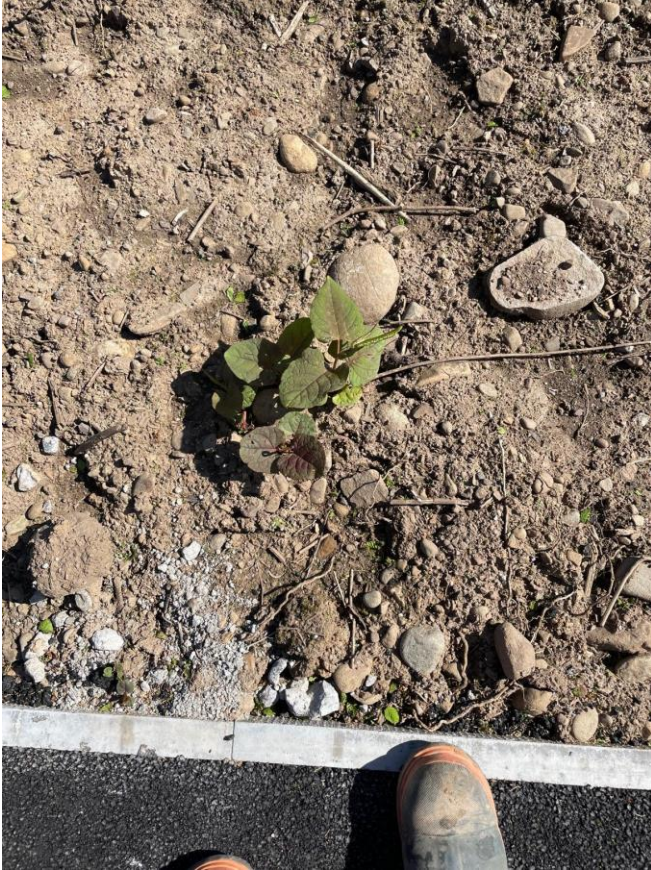
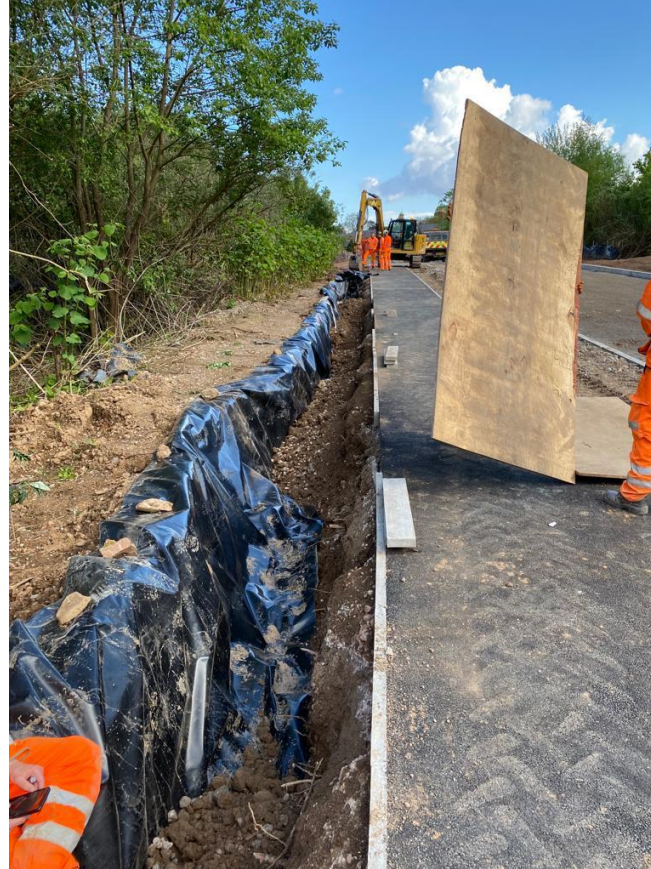
1. Image 1 shows the re-emergence of JK at the TCAR2 verge areas on **22/04/23** which led to the proposals for the installation of further vertical barriers to protect the permanent TCAR2 works.

6. A further precautionary operation as shown opposite was undertaken on **11 May 2023** where a vertical JK barrier was introduced to protect the TCAR2 footprint from JK spread from the north verge. The JK at the location to the north of this protective barrier could not be excavated and disposed of because the areas were outside of the Enabling Works Project footprint. A spray treatment programme is in place

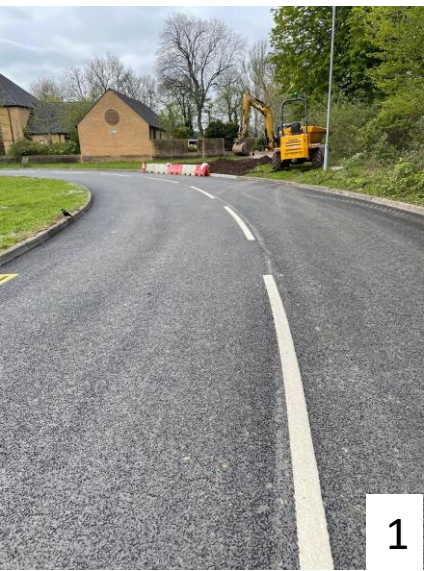
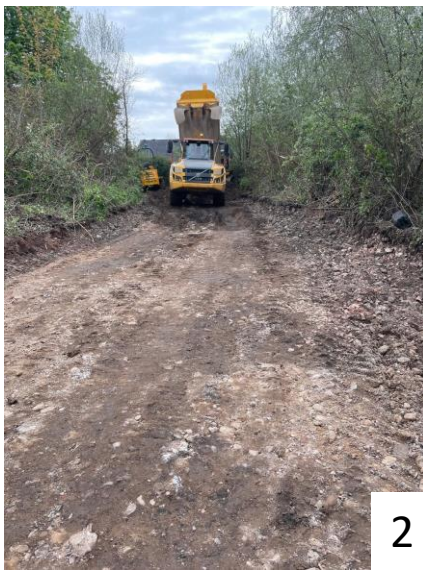
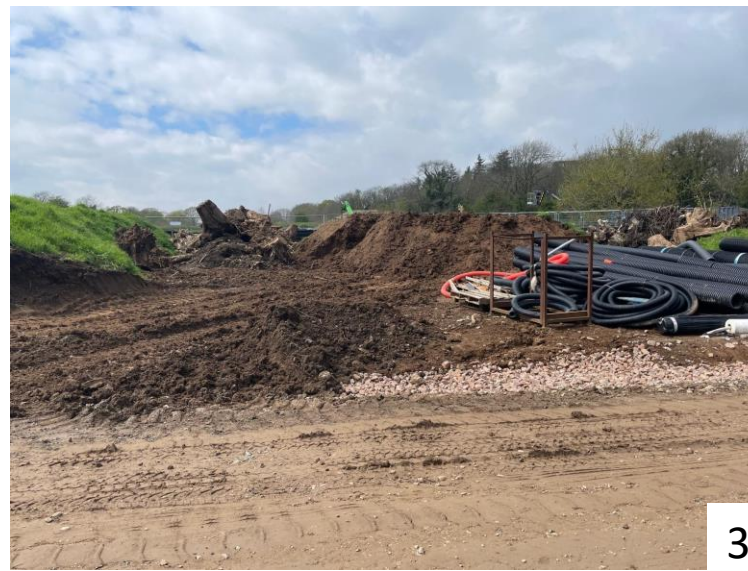
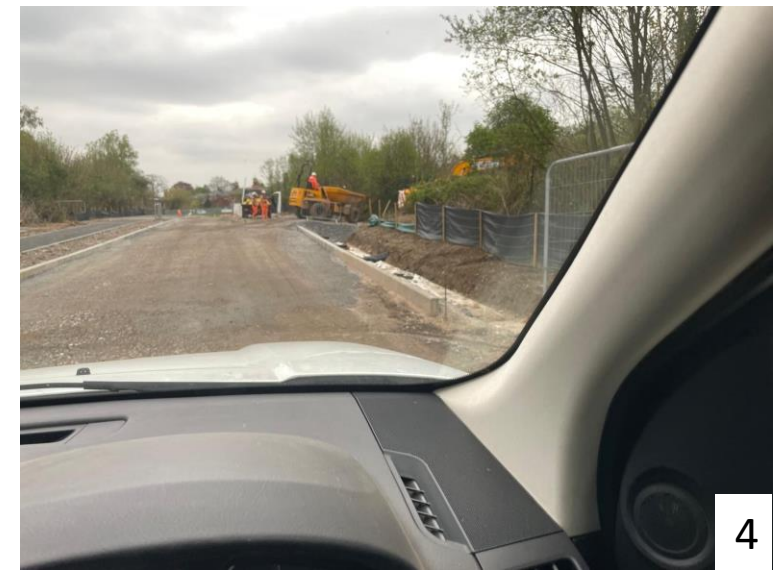
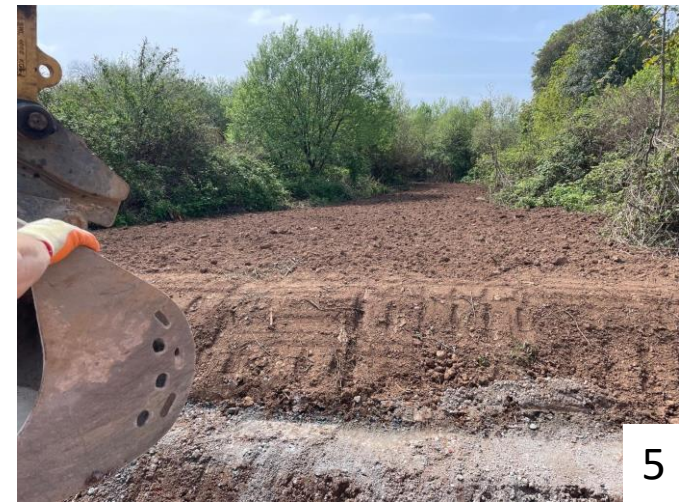
These 5 images included show the topsoiling operation underway at TCAR1

1. Image 1 shows the works commencing at the verge in Whitchurch Hospital Grounds adjacent to City Hospice. The dumper is delivering soil from the main compound of the Enabling Works Project
2. Image 2 shows the works progressing along TCAR 1 where both dumpers and dump trucks can be used on the internal site roads network, again bringing soil from the main Enabling Works compound
3. Image 3 shows the topsoil stockpiles and stumps at the main Enabling Works compound being excavated for transport to TCAR 1
4. Image 4 shows the dumper entering TCAR1 towards the City Hospice side with a stone filled crossing of the drainage ditch/swale.
5. Image 5 shows the completed topsoiling of the TCAR1 towards City Hospice prior to the planting being undertaken

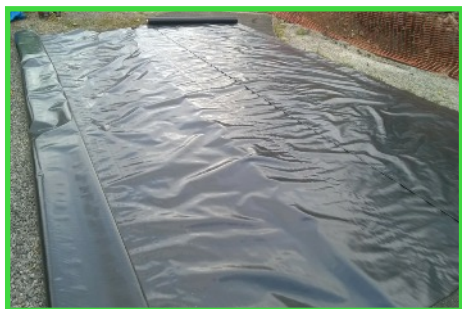
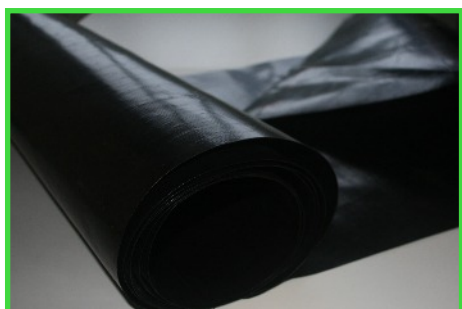
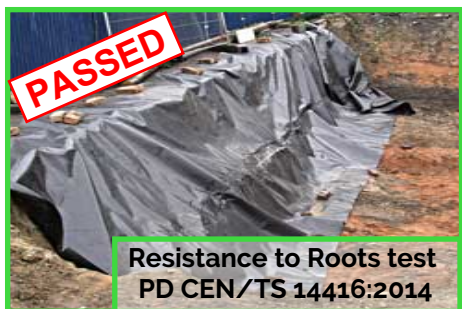
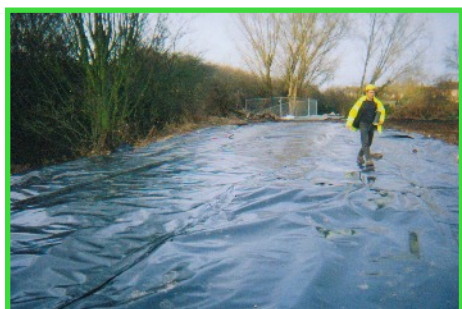
### Root Barrier C3

**A triple coated linear barrier designed to protect structures and services from root damage and control the spread of invasive plants.**
